BRANFORD RIVER BASIN
NORTH BRANFORD, CONNECTICUT

LAKE GAILLARD DAM
CT. 00387

PHASE I INSPECTION REPORT
NATIONAL DAM INSPECTION PROGRAM

SEPTEMBER 1978

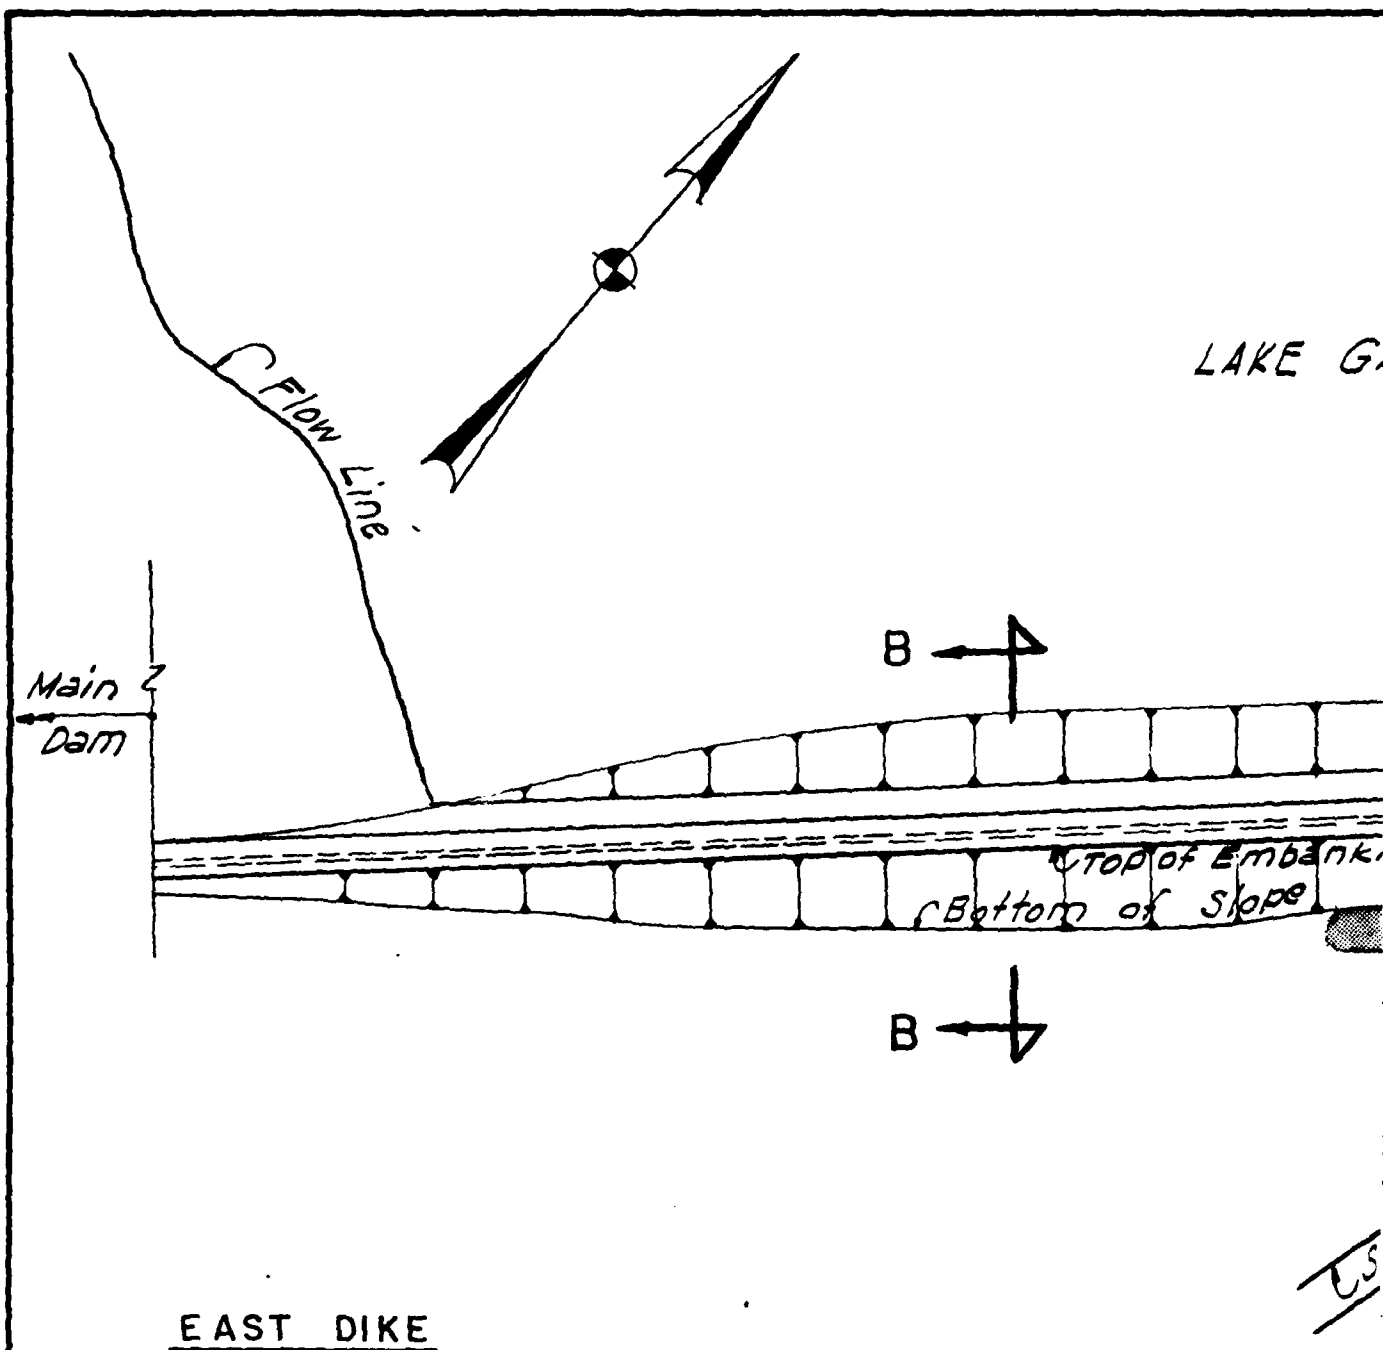
The east dike where the water level is approximately 3 to 5 feet below the spillway crest has a straight alignment with no signs of movement or distress. In two spots that are delineated on Plate 2, Appendix B, there are wet or soft areas which are usually dry only during the month of August. Although these spots are spongy, there is no visible sign of any seepage.

DENOTES WET SPOT
